# **WEENTECH Proceedings in Energy**

## **Volume 2: International Seminar on Renewable Energy and Sustainable Development**

## MONITORED ENVIRONMENTAL CONDITIONS IN NEW ENERGY EFFICIENT HOUSING IN SCOTLAND – EFFECTS BY AND ON OCCUPANTS

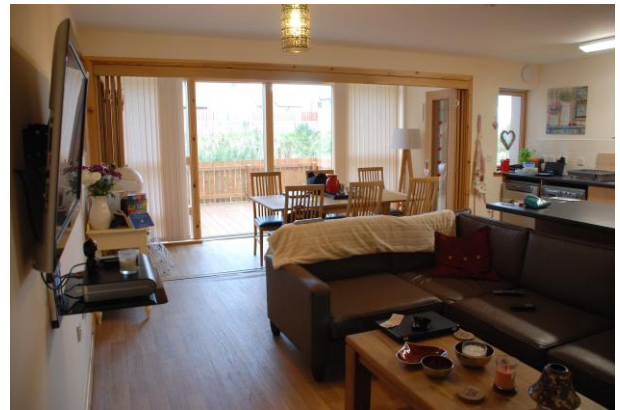
*Figure 1: Open-plan living area, Case Study 2.*

The study found that the sunspace design was compromised due to the omission of high level openings. The internal bi-fold door sets, designed to form the thermal envelope, were downgraded from double to single glazed units and the outer glazing became double glazed to form the thermal envelope. This change undermined the ability of the sunspace to perform as the design intention and combined with the much reduced living area meant the occupants expanded into the sunspace area by permanently leaving the bi-fold doors open. The initial interviews with both sets of occupants revealed they liked their homes and particularly enjoyed the social benefits of the open-plan layout. However there were shortcomings with the properties which included; summer overheating, draughts, impact noise issues from properties above and heating control and hot water generation issues. The monitoring of internal

The residual sunspace was found to have negatively impacted thermal comfort in both the summer and winter months. In summer the internal temperatures are high, partly due to reduced ventilation opportunities and solar gains through the large west facing glazed façade. The design phase compliance software warned of the 'HIGH' likelihood of high internal temperatures, yet the glazed façade was not optimised. Summer temperature peaks in the now occupied sunspace reached 36°C and the open-plan living room simultaneously reached 31°C. CIBSE guidance [5] suggests temperatures greater than 28°C for more than 1% of the year in a living room is termed overheating. The occupants found difficulty in cooling the space and used electric fans to create air movement. On cloudy days and at night in the winter, the surface temperatures of the double glazing provided a cooling effect through draughts which affected occupant thermal comfort, particularly for one household where their sofa is positioned in the sunspace. The sunspace operation was also compromised by advice from the police to use internal curtains or blinds on the external glazing to improve security during the day (although this is a low-crime area). This resulted in fewer winter solar gains. To compensate for this the occupants increase the thermostat setting to 23°C on one dwelling and in the neighbouring property the occupants have placed their sofa against the only radiator in the open-plan space and consider their heating to be ineffective. The dwellings are served by a communal biomass system which also had technical difficulties and the occupants reported an inability of the heating system to simultaneously provide heat in the open-plan living room and the two bedrooms. To overcome this, bedroom radiators had been turned off. However, the (small) master bedroom maintained a comfortable temperature despite its north facing aspect and lack of solar gain. Thermography revealed the fridge/freezer and radiator in the adjacent open-plan living space was heating the separating wall and acting as a large low surface temperature radiator in the master bedroom. Hot water outlets in the bathrooms are

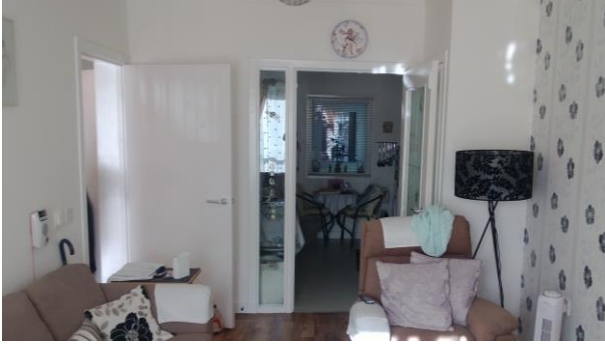
Figure 2: Living room with glazed partitions to kitchen for borrowed light, Case Study 3.

The kitchen is ventilated using a central mechanical extract unit which also serves the bathroom. This is light switch controlled and consequently activated when the bathroom and kitchen lights are on. The occupant had complained that the extract fan was not sufficient at removing smells from the property. The study identified poor quality of installation leading to the exhaust duct separating from the extract unit (located in the hall cupboard) which resulted in moisture, cooking smells and cigarette smoke extracted from the kitchen being dumped in to the hall cupboard and then distributed around the flat. This had implications on indoor air quality; stuffiness; smells and increased potential for microbial activity, which would have health implications for the occupant. Inadequacies in the extract system and increased use due to the lighting problem impacted on energy consumption, both through the ventilation system and the increased energy consumption from the kitchen lighting.
